Ford 4.0L V6 Engine

The original 2.6L engine was replaced by the 2.8L, which was upgraded to the 2.9L and then finally bored and stroked to make it into the 4.0L that was used in the Rangers, Aerostars and Explorers starting in 1990. It was replaced by a SOHC engine from this same family at the end of model year 2000.

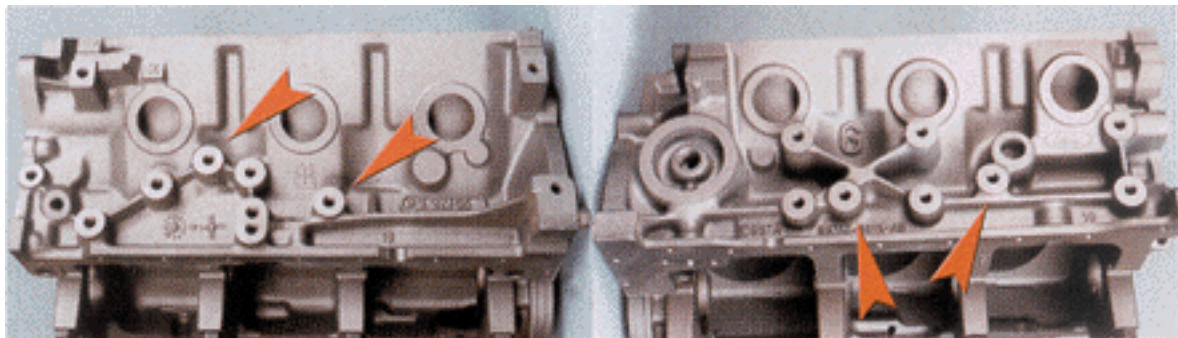
The 95TM block had two more bolt bosses added on the driver's side and two more on the passenger side.

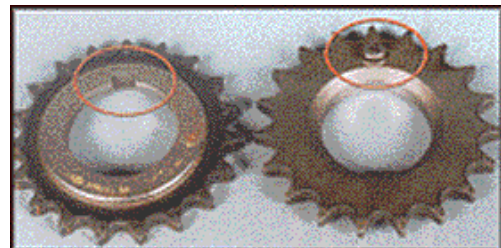
The original crank gear (right) had a small, raised tab sticking out from the back side of the gear that fit into the notch that was machined in the crank. The later design had a slot machined in the gear for a Woodruff key.

The early crank gear has caused problems for many rebuilders. The crank gear was timed to the crankshaft by the small tab on the back of the gear that fit into the shallow notch that was machined in the step at the back of the snout. There is nothing to hold the gear in place against this step until the damper is installed, so it wants to slide forward and jump out of time during assembly, test and installation. Most rebuilders knurl the shaft or stake the gear in place to try to prevent the gear from moving, but that doesn't always work, especially if the installer isn't aware of the possible problem. Be sure to warn your assemblers and your customers so you don't have to pay somebody to take it apart and do it over again.

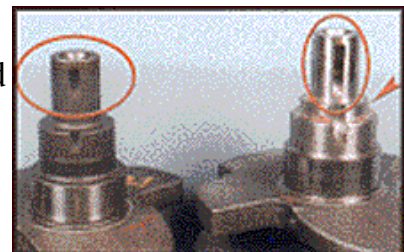
The crank was machined for a full-length Woodruff key (right) in late '95. Note: the second step that was added, too.

while the slot in the later 90TM-AA casting was 0.673? long. This change occurred sometime during model year '95, but the big change came even later in the year when the snout was machined for a full-length Woodruff key and a second step was added for an another gear.

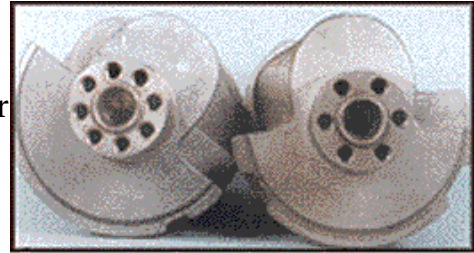
The mounting flange for the flywheel was changed from a six bolt to an eight-bolt pattern in '97.

The crank was revised again in '97. The new 97JM-AC casting came with an additional step, the long keyway and an eight-bolt flange for the flywheel. This was the same casting that was used in the SOHC 4.0L for '97 and '98, so the cranks from both engines can be interchanged, in spite of the fact that Ford gave them different part numbers.

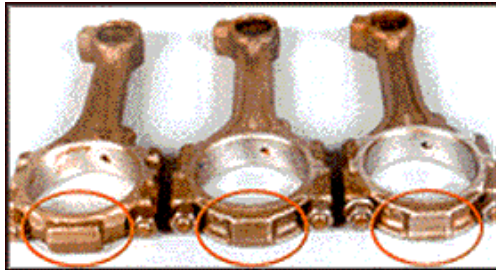
There have been four different rods used in the 4.0L. The fourth one is a machined version of the one on the left. We keep them in matched sets according to the size and the shape of the balance pads.

There have been three different rods used in the 4.0L, including the FBOCA, the FBOCB and the 7AE, but the forging numbers don't tell the whole story because the weights are not consistent with the numbers. These rods vary from a low of 560 grams to a high of 590 grams, so you can end up with a shaker unless you keep them in matched sets by weight. Some rebuilders weigh each rod and others sort them based on the appearance of the weight pads on the bottom of the big end (see photo). Both ways seem to work, so it really doesn't matter how you go about sorting them as long as you keep them in matched sets.

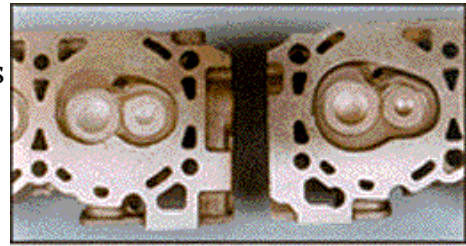
The early heads (right) has on an open, oval-shaped chamber that was bigger on one end while the later ones (left) had smaller, heart-shaped, fast-burn chamber.

The original 90TM casting had an oval-shaped chamber that was slightly bigger in diameter on the intake side. It was replaced in '93 by the 93TM-AA casting that was exactly the same. These heads can be identified by the letter "T" located on the top of the right rear/left front exhaust port.

The 95TM-AD casting that came out in '95 had the heart-shaped, fast-burn chambers that shrouded the intake valves. It was replaced by the 97TM casting in '97, but it was the same, so they can be used interchangeably. These castings were used on the Ranger and Explorer from '95 through '97 and on the Aerostar in '97. They can be identified by the letter "U" that's located on the top of the right rear/left front exhaust port.

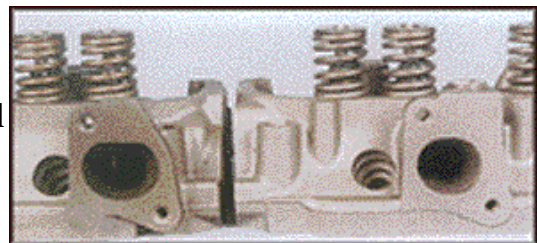
The exhaust ports on the 98TM casting (right) are considerably narrower than the ones found on the earlier 95TM/97TM castings (left).

Ford introduced another new head in '98. The exhaust ports on the 98TM-AD were much narrower than they were on the earlier castings; they measured 1.40" across the port compared to 1.70" on the 95TM/97TM castings. According to the engineers I have talked to, the smaller ports increased the velocity of the exhaust gasses so they carried more heat down to the catalytic converter. This helped the converter "light off" sooner, so it did a better job of reducing emissions during the critical start-up and driveaway phase of the EPA emissions test. With that in mind, it's probably not a good idea to swap these heads back and forth with any of the earlier castings.

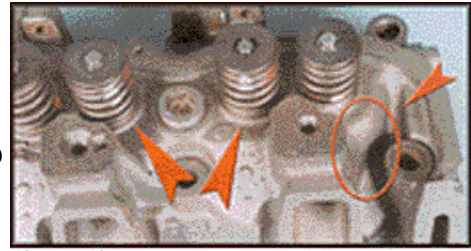
The 90TM heads tended to crack around the spring pads on the intake side and had porosity problems by the oil drainback holes. The later ones still tend to crack in this same area.

Many of the heads that were produced for the 4.0L in '89 and '90 tended to crack around the spring pads on the intake side and had porosity problems down in the corners where the oil drained back into the valley. The cracks on the top can be found by Magnafluxing the heads, but the porosity problems won't show up unless the head is pressure tested at about 70 psi. Some of the later heads have cracks around the oil drainback holes and quite a few are cracked in the chambers, so they should all be carefully inspected before being rebuilt. The threaded plugs on the top tend to leak, too, so they should be removed and reinstalled with sealer on the threads. Ford says they should be torqued to 80 ft.lbs after resealing them.

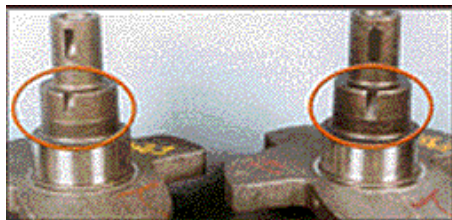
The length of the notch machined in the step was changed in '95. The notch in the 95TM-AB (left) was shorter than the one in the 95TM-AA. Both of these cranks are interchangeable.

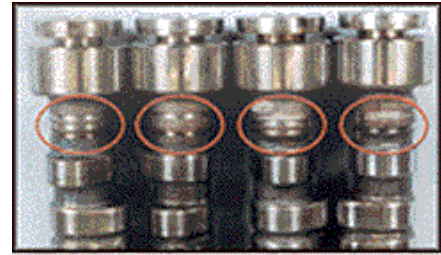
The four different camshafts are identified by the number of grooves machined in the barrel and the spacing between them. They can have one groove, two close one two wide ones or three grooves, depending on the original part number.

It really gets interesting when you get to the camshafts. There have been four different cams used over the last 10 years. Each one can be identified by the number of machined rings around the barrel and their proximity to each other, but the applications and possible consolidations can be pretty confusing, so let's start with the original part numbers along with their applications and go from there. See Chart

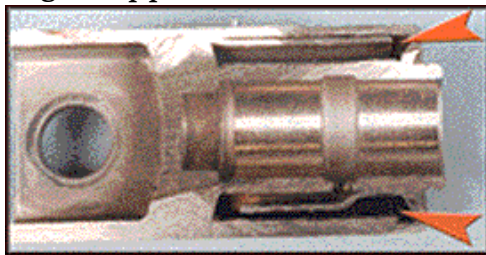
The roller lifters used in the 4.0L are hard to rebuild because they have a space between the inner and outer body that traps debris and makes it nearly impossible to get them completely clean.

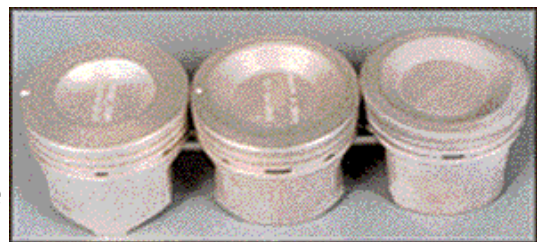
There have been three pistons used in the 4.0L. The original design (left) had a shallow dish, the second version (middle) had a deeper dish to compensate for them smaller, heart-shaped chamber, and the latest design (right) had a similar dish, but it was more squared-off in the bottom.

Ford has used three different pistons in this engine over the years. The first one had a small dish, the second one had a bigger dish and the most recent one is a lightweight version of the deep-dish design.

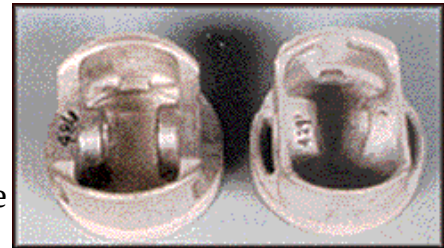
The latest piston (right) that came out in '98 is 50 grams lighter than the one used in the '97 engines. The pin bosses are closer together, the skirts are thinner and there are cavities behind the ring lands to reduce weight.

The piston was revised again in '98. The dish looked a little bit different this time, but the real difference could be seen from the bottom of the piston. The skirts were thinner, the pin bosses were closer together and there were cavities behind the ring lands on both sides, so it weighed 50 grams less than the previous design. The ring grooves were moved closer to the crown to reduce the crevice volume and the rings were narrower, too. It's a completely new design that shouldn't be interchanged with the earlier, deep-dish pistons.

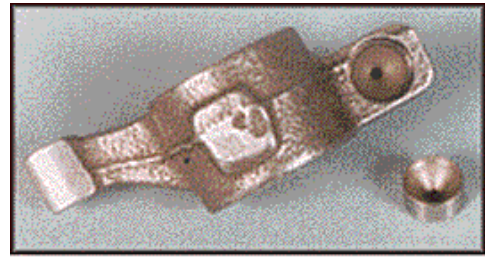
The worn pushrod socket in the rocker can be repaired by installing a new insert in the rocker. The rocker in the picture has been rebuilt with a new socket.

The pushrods and rockers on the 4.0L tend to show a lot of wear, even on engines with low miles. We suspect that there are two reasons for this problem: (1) The

material in the rockers appears to be too soft, so they wear on the tip, and; (2) there's not enough oil getting to the pushrod socket, so it gets worn out, too.

Apparently the small hole in the pushrod socket that intersects this passage is supposed to meter oil down into the socket somehow, in spite of all the motion that's trying to sling the oil out from the open end of the passage in the rocker. It's hard to believe that any oil can actually get into the sockets, so it's no wonder they wear out prematurely. Rebuilders should expect to rebuild or replace most of the rockers. The tips can be ground if they're not worn too badly and the sockets can be repaired by installing a special insert that's available along with the tooling needed from Silver Seal (800-521-2936) or Goodson (800-533-8010). Or, if you prefer to have someone do them for you, rebuilt rockers are available from Delta Camshaft at 253-383-4152.

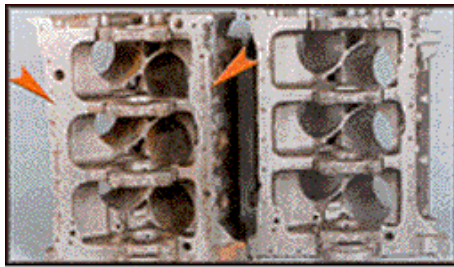
The 97TM block (left) had wider pan rails to help reduce NVH.

The block was redesigned again in '97 to reduce noise, vibration and harshness (NVH). Both of the pan rails on the 97TM-AA casting were wider and there were two more gussets added between the pan rail and the horizontal rib that's right above it on the passenger side. The dipstick hole on this block was enlarged to about 0.435?, too.

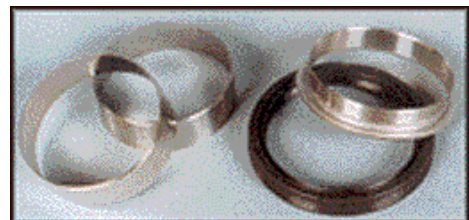
Rebuilders should always cover the factory seal with a sleeve Ford offers a kit with a seal and a sleeve (right), but most rebuilders prefer to use a sleeve from Micro Sleeve or Classic.

The rear seal on the 4.0L has always been prone to leakage. It appears that the original factory finish on the seal surface was too slick, so the seal just couldn't control the oil. Ford offers a repair kit that comes with a sleeve and a seal (p/n F5TZ-6701-A), but it costs about \$50 at the dealership. Rebuilders should definitely install a sleeve over the factory seal surface, but there are better alternatives in the aftermarket; Micro Sleeve (800-475-3383) and Classic (800-393-0544) both offer sleeves for the 4.0L cranks.
